CLEAN WATER ACT  
COMPLIANCE INSPECTION

Investigation Date(s)

On-Site June 15, 2011

Fly-over November 9, 2010

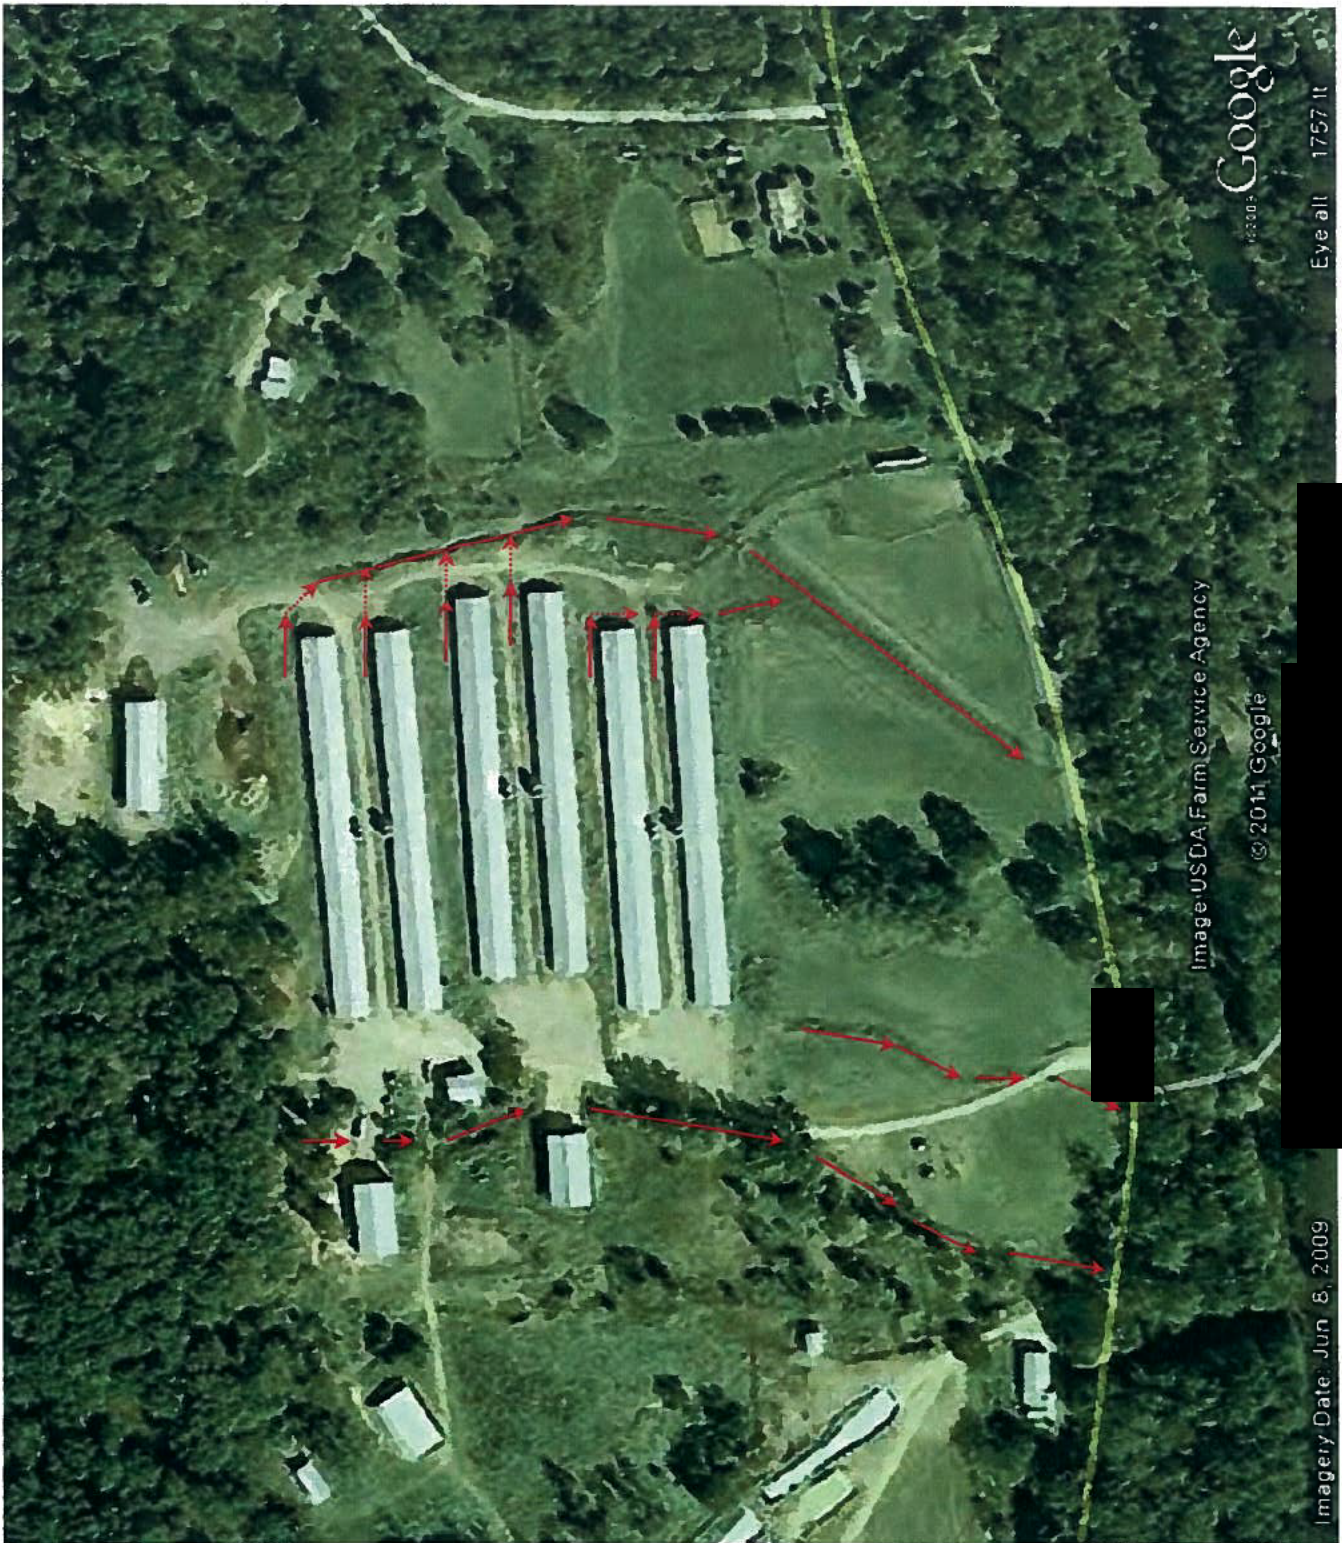
Site Map 3

There are three primary drainage pathways that drain the areas around the manure sheds and poultry houses as shown on Site Map 3. The first is a waterway that runs in front of the east end of the manure sheds. The waterway appears to begin in the wooded upland. A cow was observed in the waterway, but there was no water. The portion of the waterway near the manure sheds is a V-shaped channel. The slopes are dirt without any vegetation. Access lanes to the front of the manure sheds were constructed through the waterway. There are culverts that measure 36" in diameter that run underneath the access lanes to each shed. This waterway had pocket of wet spots but no flowing water. Ponded water in the waterway appeared sediment-laden. This waterway goes under ██████████ and flows to ██████████ The culverts under the road were observed.
